Technical Report

**Weathertightness testing of a sample
of Matrix SFM Rainscreen Cladding
for PSP**

N950/08/14075REV1
08 FEBRUARY 2019

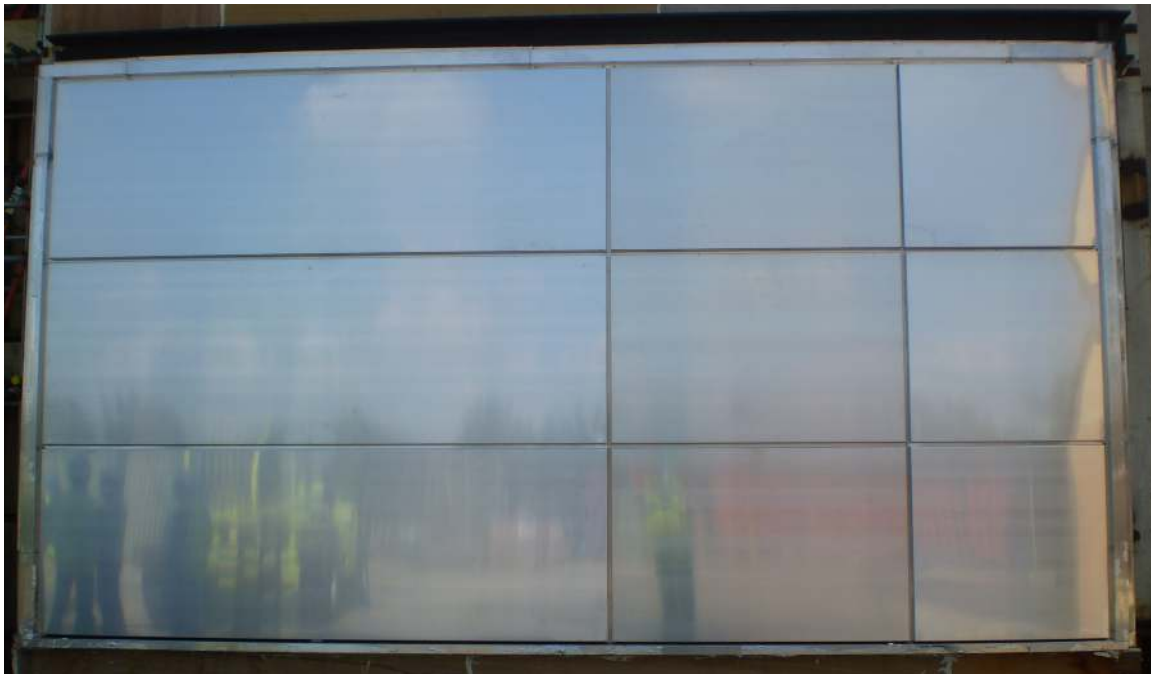
PHOTO 6050074

TEST SAMPLE ELEVATION

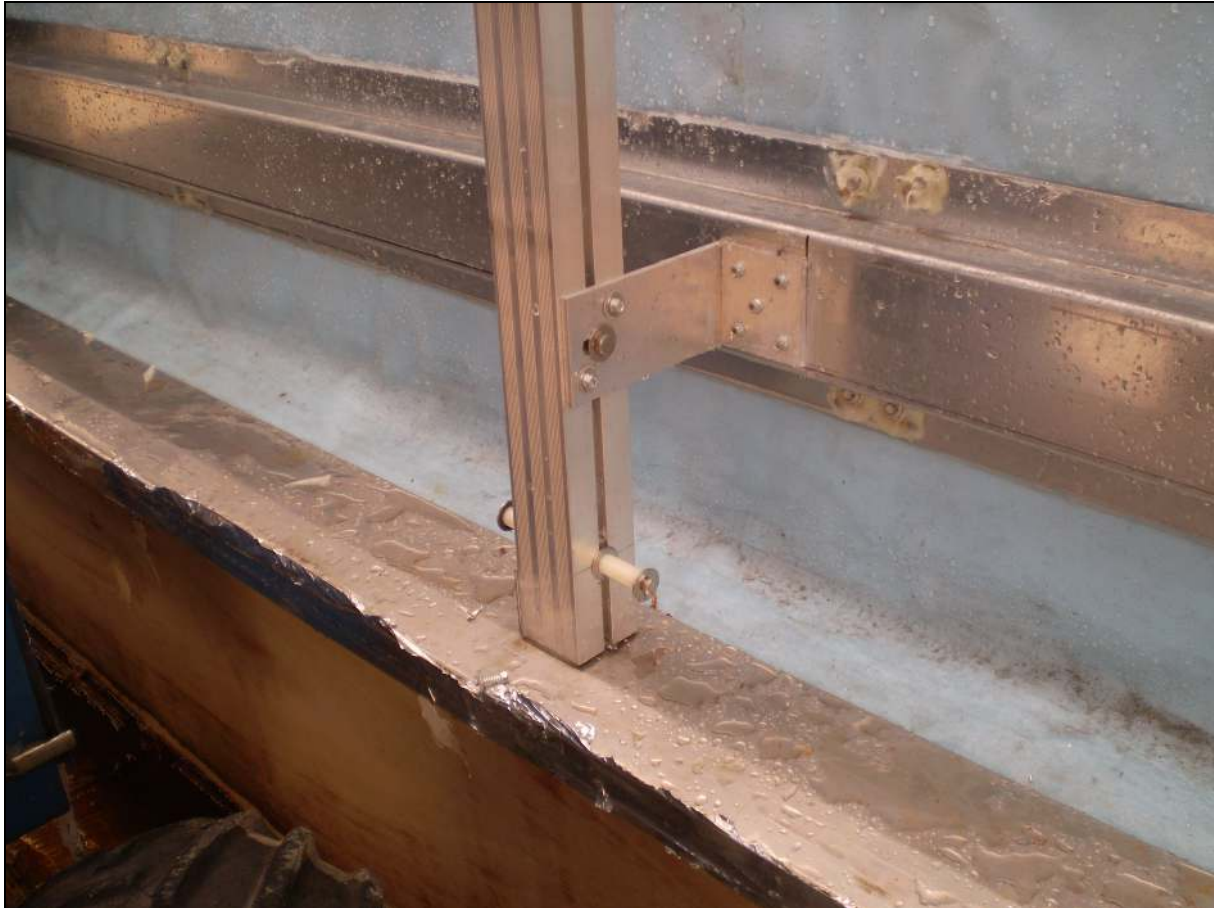
PHOTO P6050078

During the dismantling of the sample no discrepancies from the drawings were found.

SUPPORT FRAME

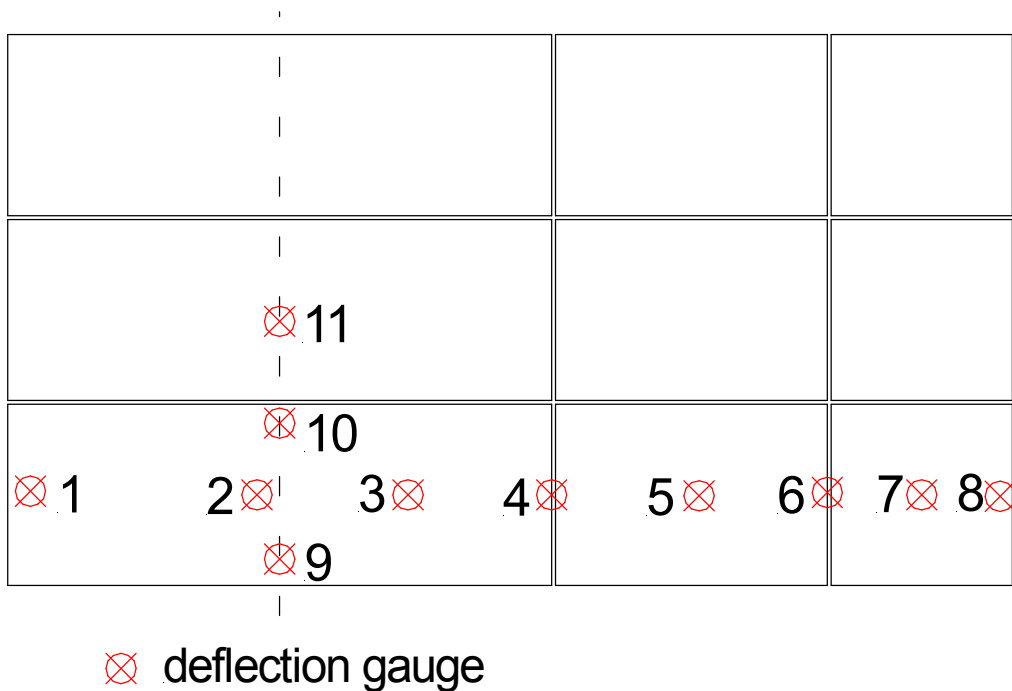
FIGURE 2

DEFLECTION GAUGE LOCATIONS

Gauge number	Member	Pressure differential (Pa)	Measured deflection (mm)	Residual deformation (mm)
3	Back of panel	2400	2.9	0.4
		-2386	-2.8	-0.8
5	Back of panel	2421	17.7	0.3
		-2386	-13.8	-0.3
7	Back of panel	2421	19.2	0.0
		-2386	-15.2	-0.1
10	Back of support rail	2421	8.7	0.1
		-2386	-7.4	0.0

No damage to the test sample was observed.

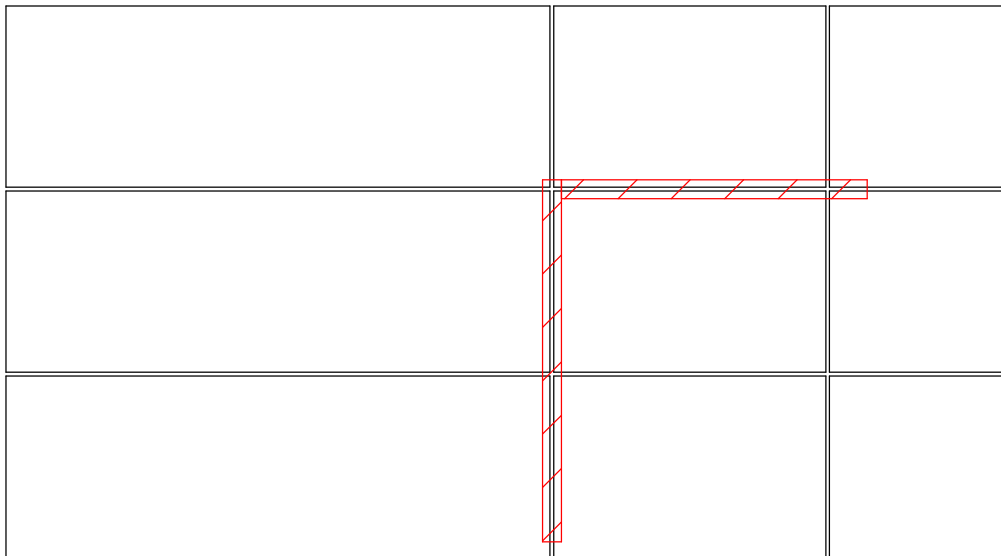
FIGURE 3

HOSE TEST AREAS

Minor leakage confined to back of rainscreen panels and rails.

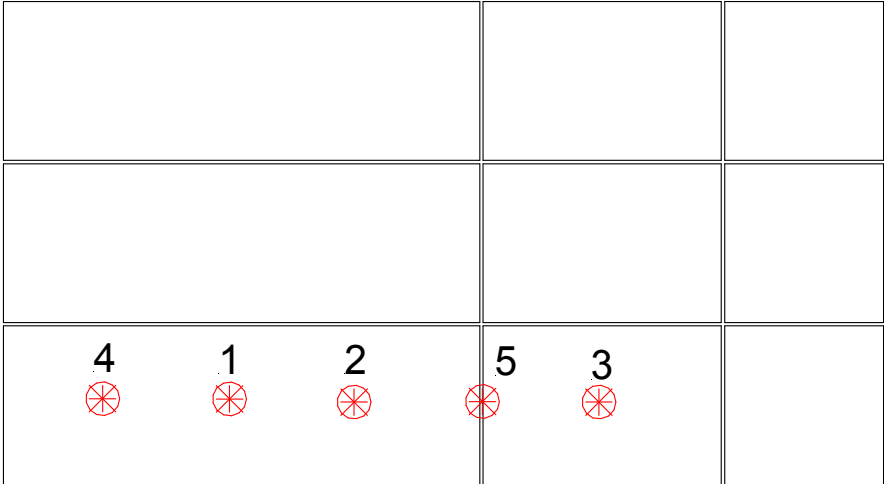
FIGURE 4

500 Nm soft body: Bottom of panel bent in but remained secure.

500 Nm soft body. Bottom of panel bucked but remained secure.

10 Nm hard body: Small indent observed – 0.5 mm deep.

10 Nm hard body: Small indent observed – 1 mm deep.

IMPACT TEST LOCATIONS

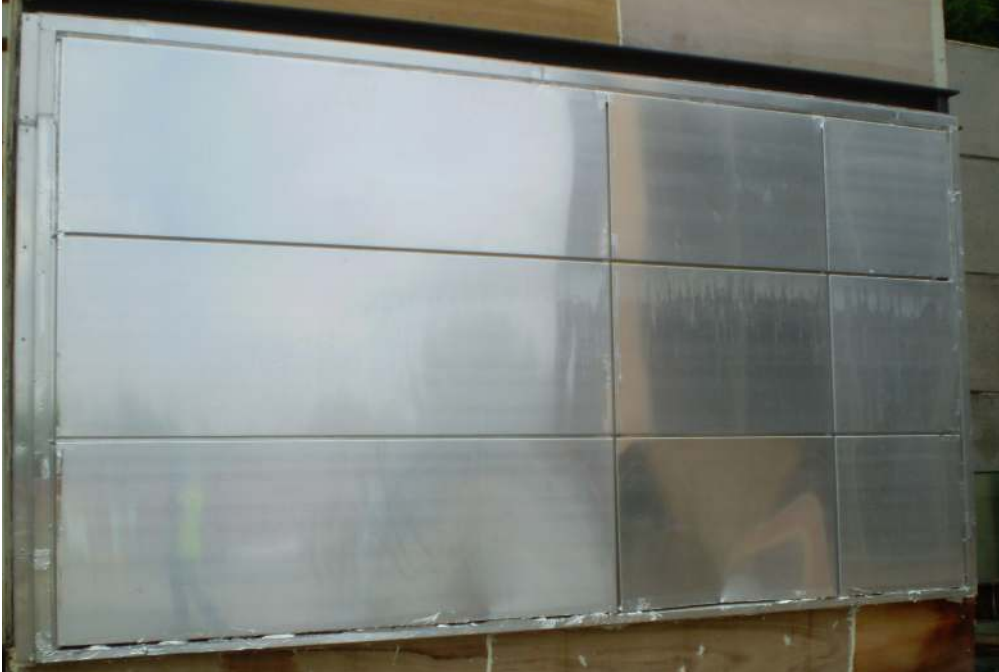
PHOTO 6050074

SAMPLE AFTER IMPACT TESTS
