Title: Product weathertightness and impact testing of a sample of PSP
Architectural Matrix SF and Matrix SFC Rainscreen Cladding

Report No: N950-12-16557rev1

Client: PSP Architectural Limited, Unit 11, All Saints Industrial Estate, Shildon, Co Durham DL4 2RD

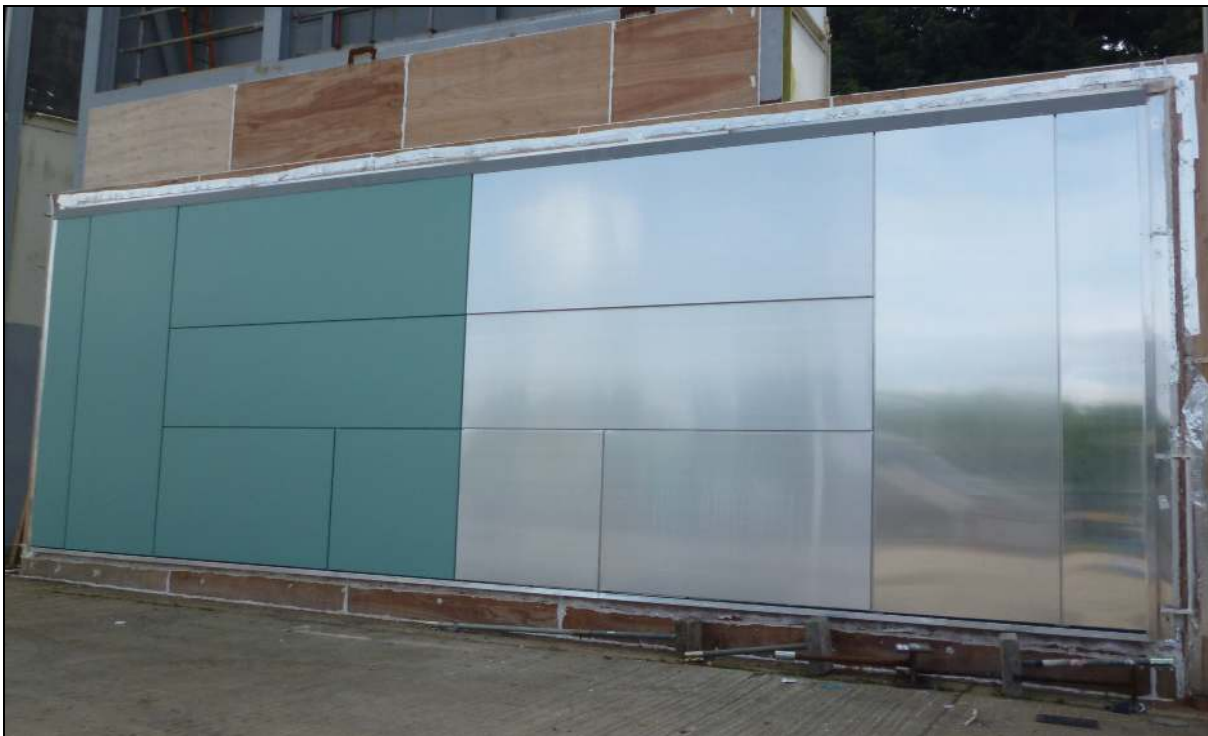
PHOTO 1010851

The test sample measured 4 m high by 12 m wide.

Insulated backing wall panels were screwed onto the 100 mm x 100 mm steel angles of the test rig support frame. A water proof membrane was located over the backing wall panels and then the Matrix T carrier frame and support brackets were secured to the backing wall.

The aluminium Matrix SF and SFC rainscreen panels were then secured to the carrier frame.

TEST SAMPLE ELEVATION

The sample was as shown in the photo below and the drawings included as an appendix to this report.

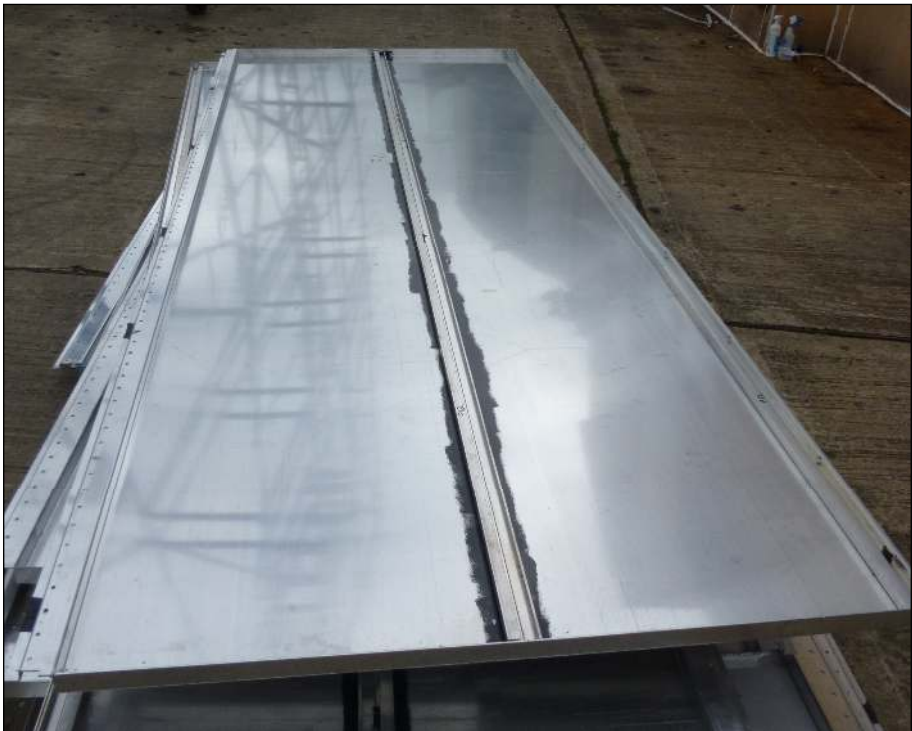
PHOTO 1010987

BACK OF MATRIX RAINSCREEN PANEL

During the dismantling of the sample no water penetration or discrepancies from the drawings were found.

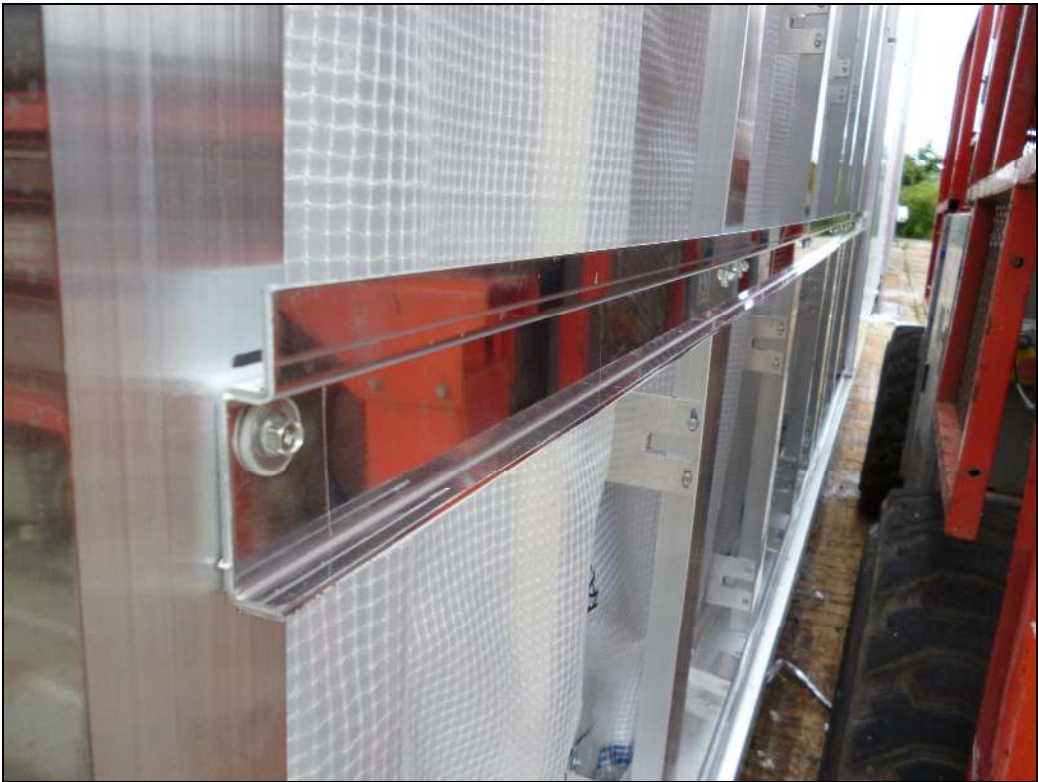
PHOTO 1010979

MATRIX CARRIER FRAMEWORK

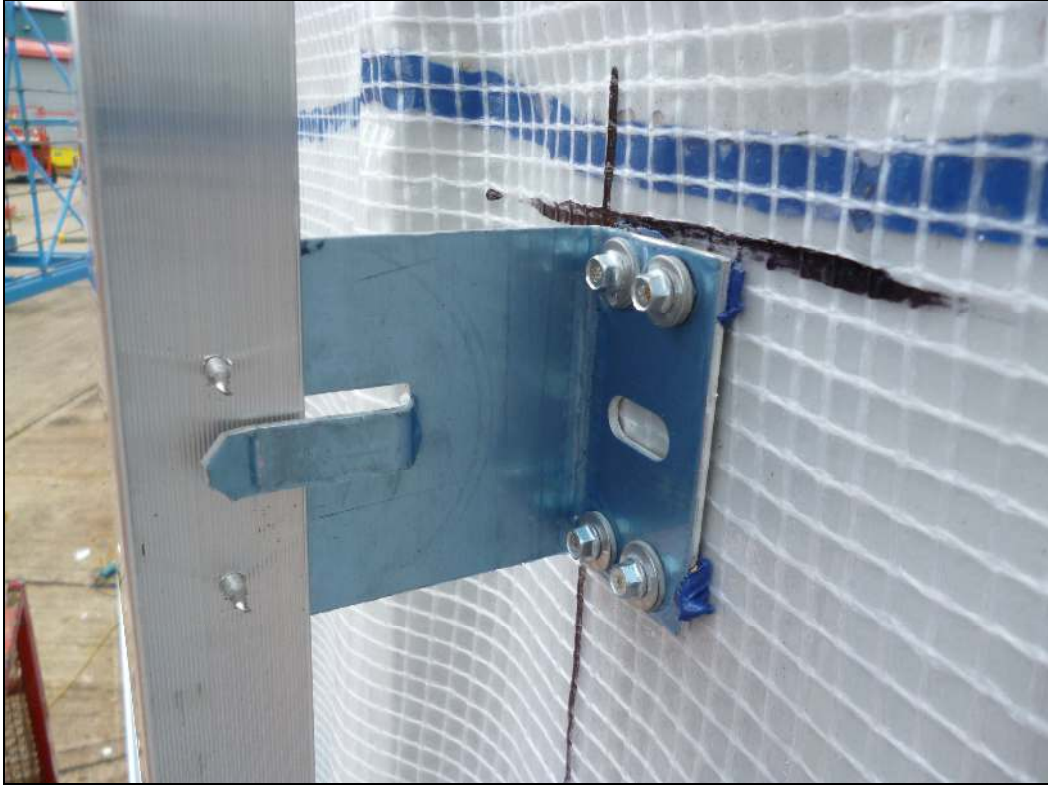
PHOTO 1010982

CARRIER FRAME SUPPORT BRACKET

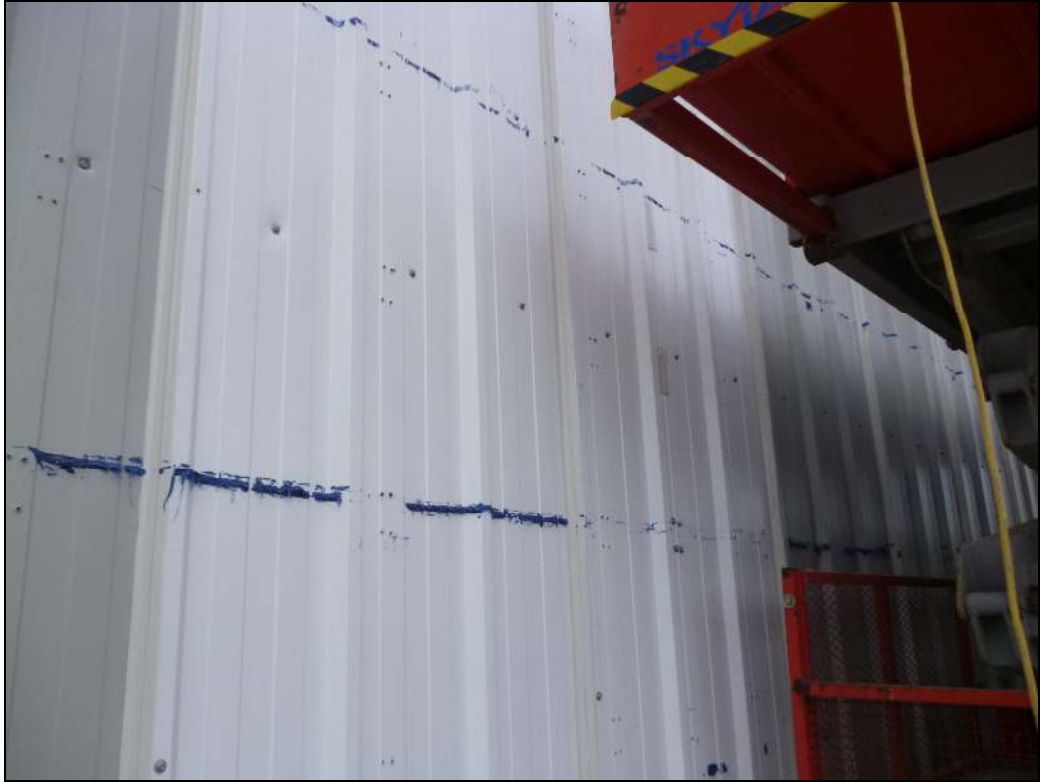
PHOTO 1020030

VIEW OF BACKING WALL PANELS

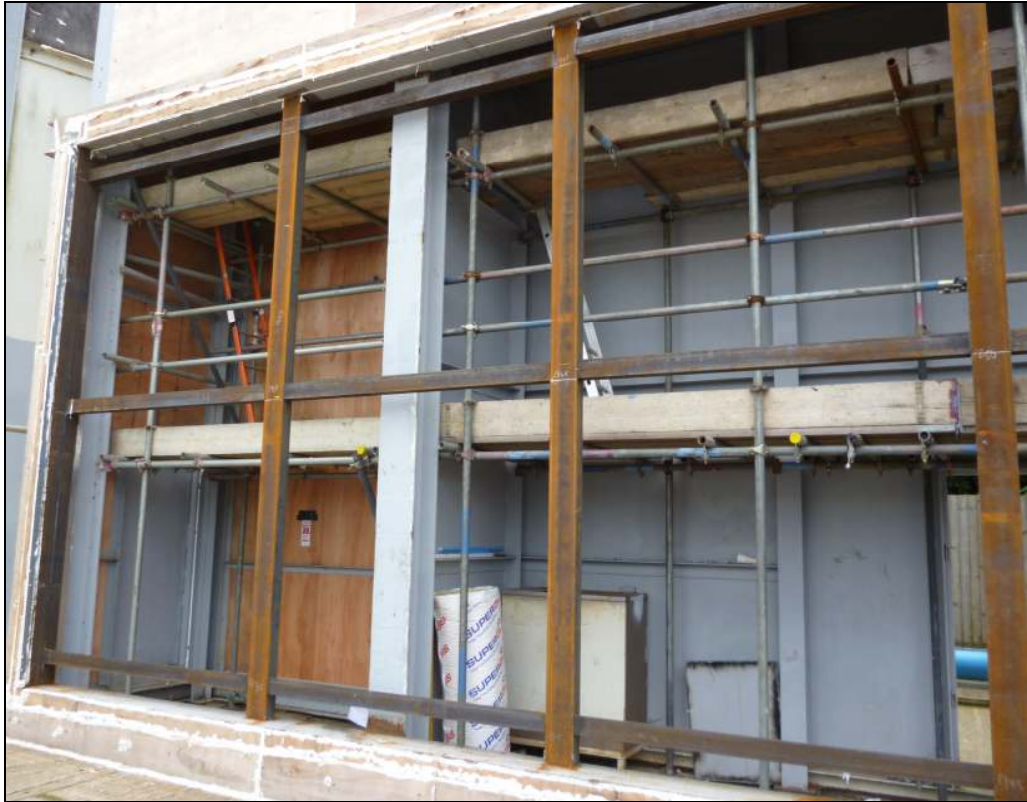
PHOTO 1020044

TEST RIG STEEL SUPPORT STRUCTURE

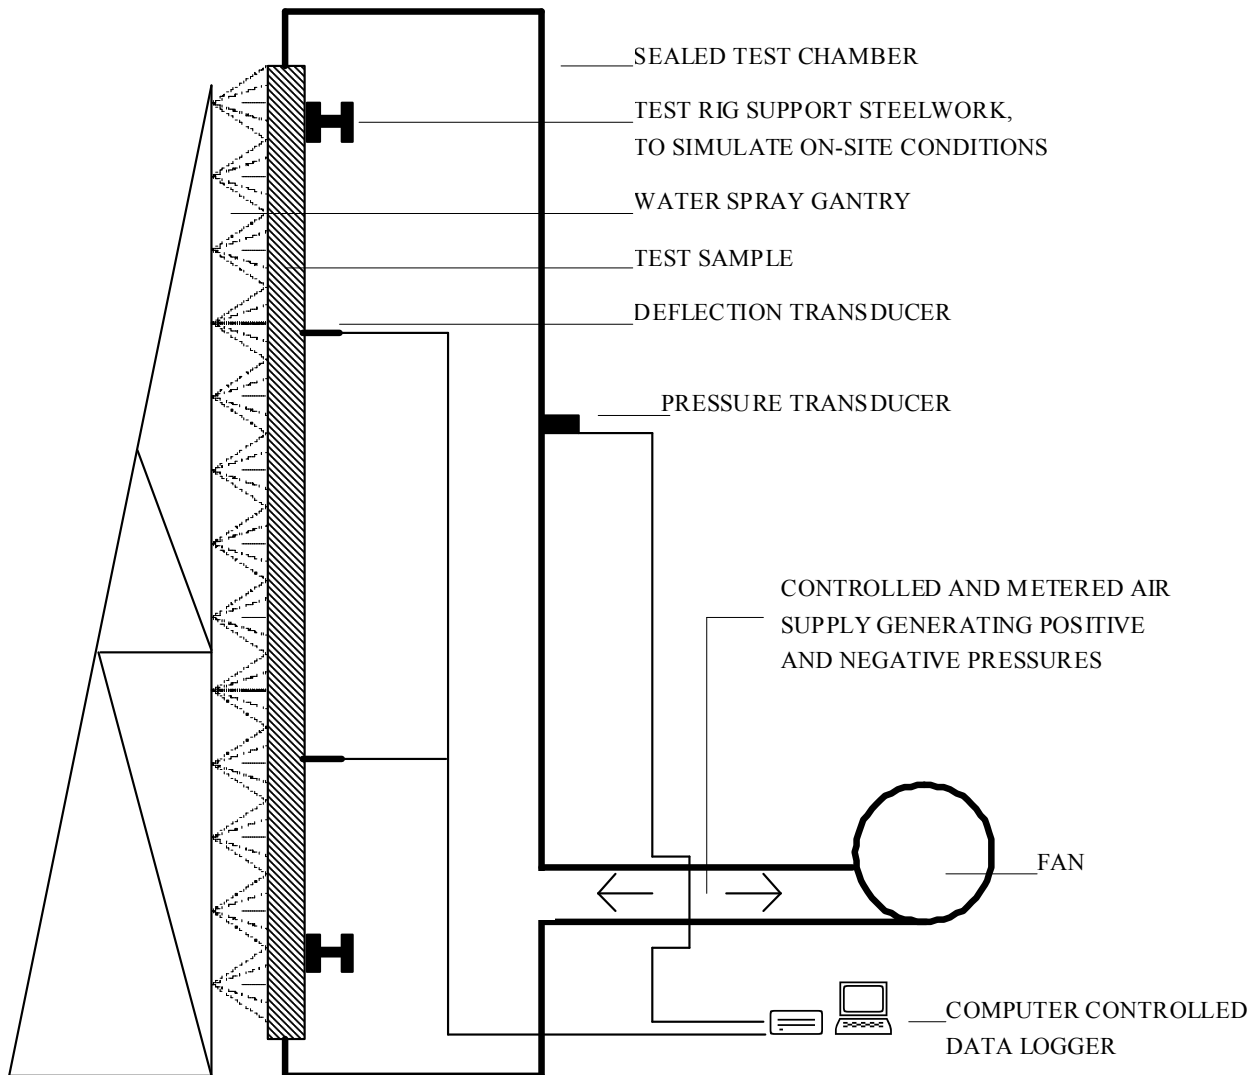
FIGURE 1

The test sample was mounted on a rigid test rig with support steelwork designed to simulate the on-site/project conditions. The test rig comprised a well sealed chamber, fabricated from steel and plywood. A door was provided to allow access to the chamber. Representatives of PSP Architectural Limited installed the sample on the test rig. See Figure 1.

TYPICAL TEST RIG SCHEMATIC ARRANGEMENT

SECTION THROUGH TEST RIG

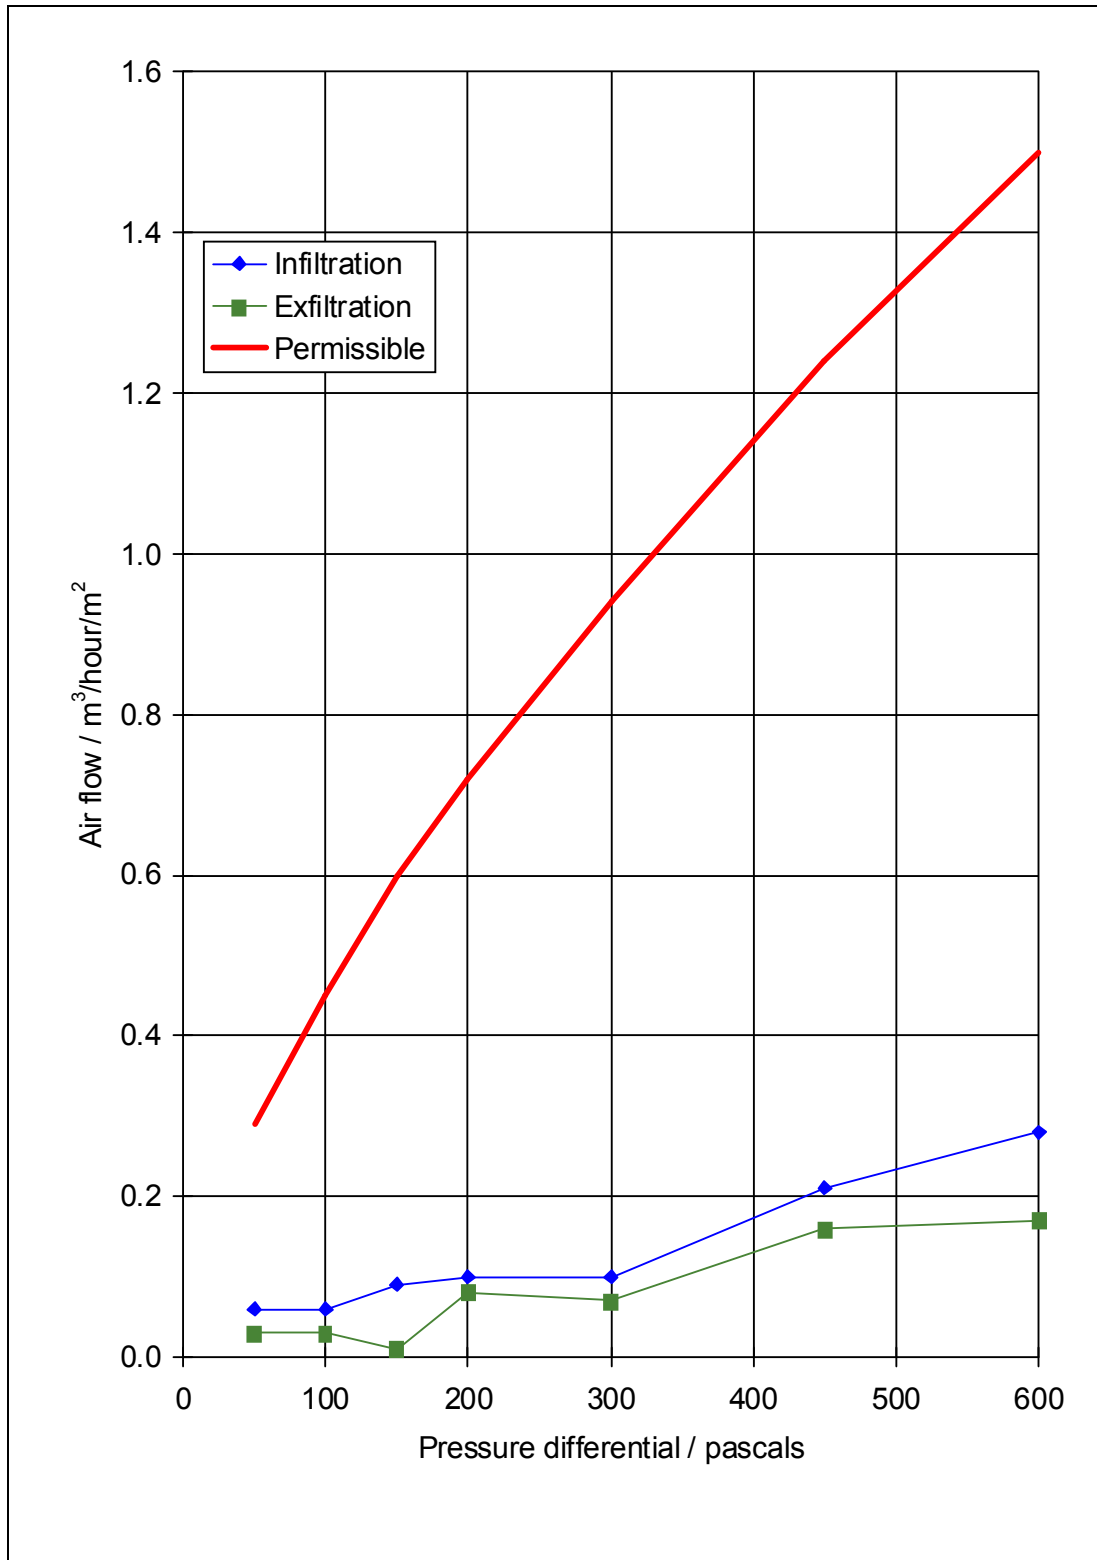
FIGURE 2

Air permeability test results

Pressure differential (pascals)	Measured air flow through sample (m ³ /hour/m ²) Test 2 Date: 27 June 2012	
	Infiltration	Exfiltration
50	0.06	0.03
100	0.06	0.03
150	0.09	0.01
200	0.10	0.08
300	0.10	0.07
450	0.21	0.16
600	0.28	0.17
Temperatures	Ambient = 23°C Chamber = 24°C

The results are shown graphically in Figure 2.

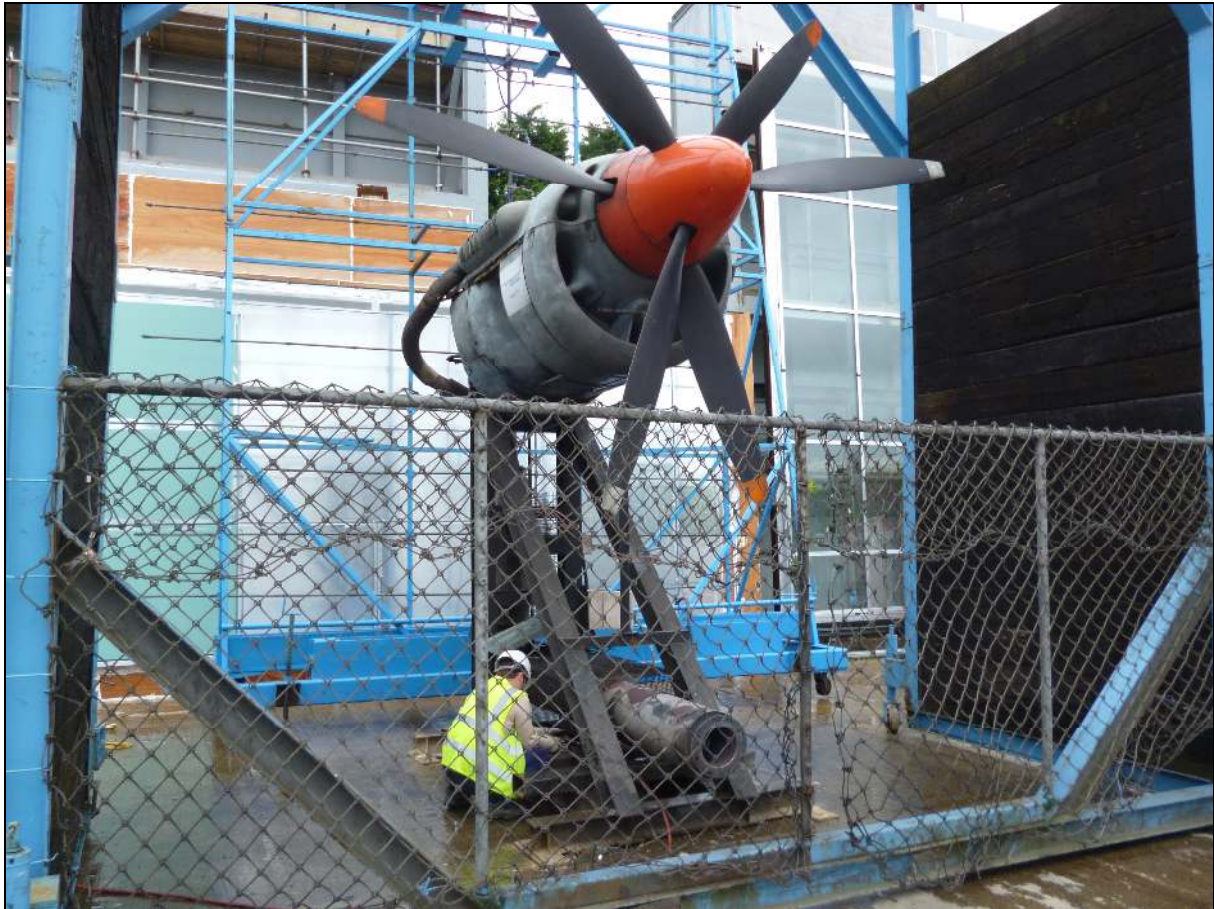
A wind generator was mounted adjacent to the external face of the sample and used to create positive pressure differentials during dynamic testing. The wind generator comprised a piston type aero-engine fitted with 4 m diameter contra-rotating propellers.

WIND GENERATOR

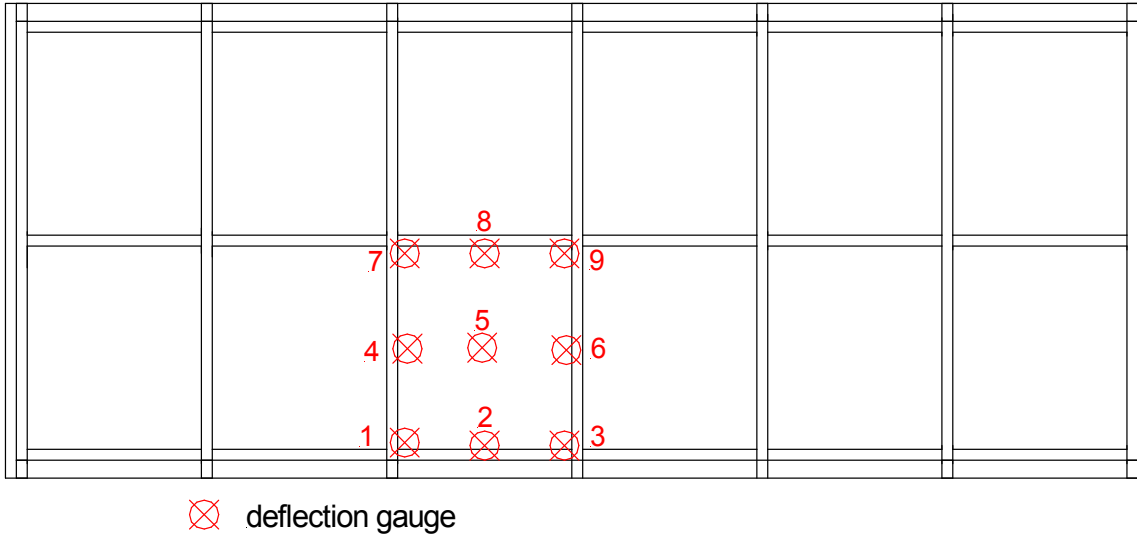
FIGURE 3

Displacement transducers were used to measure the deflection of principle framing members to an accuracy of 0.1 mm. The gauges were set normal to the sample framework at mid-span and as near to the supports of the members as possible and installed in such a way that the measurements were not influenced by the application of pressure or other loading to the sample. The gauges were located at the positions shown in Figure 3.

DEFLECTION GAUGE LOCATIONS

Internal View

The deflections measured during the wind resistance test, at the positions shown in Figure 3, are shown in Tables 4 and 5.

The deflections measured during the structural safety test, at the positions shown in Figure 3, are shown in Table 6.

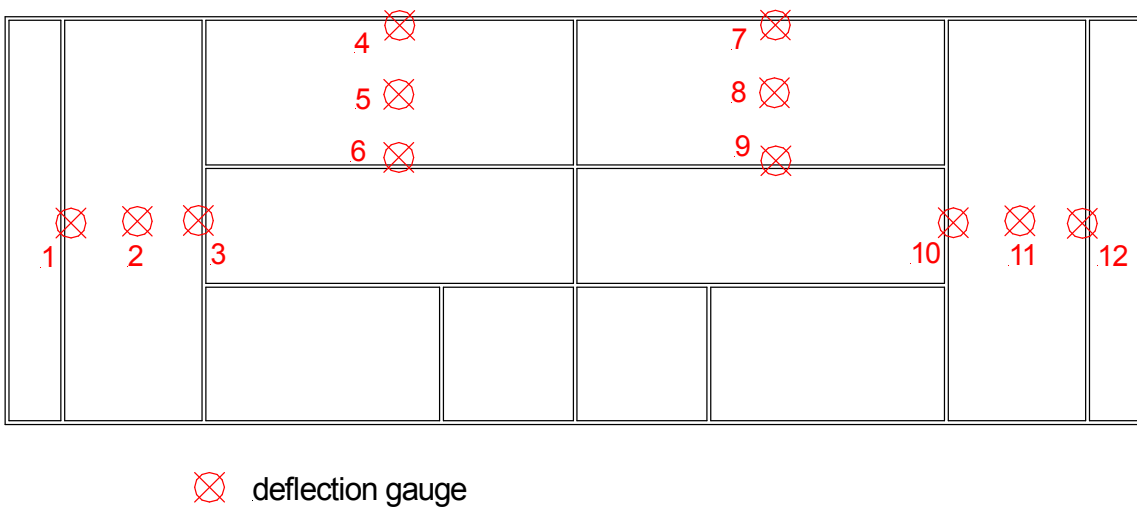
FIGURE 4

DEFLECTION GAUGE LOCATIONS

External View

The deflections measured during the wind resistance test, at the positions shown in Figure 4, are shown in Tables 7 and 8.

The deflections measured during the structural safety test, at the positions shown in Figure 4, are shown in Table 9.

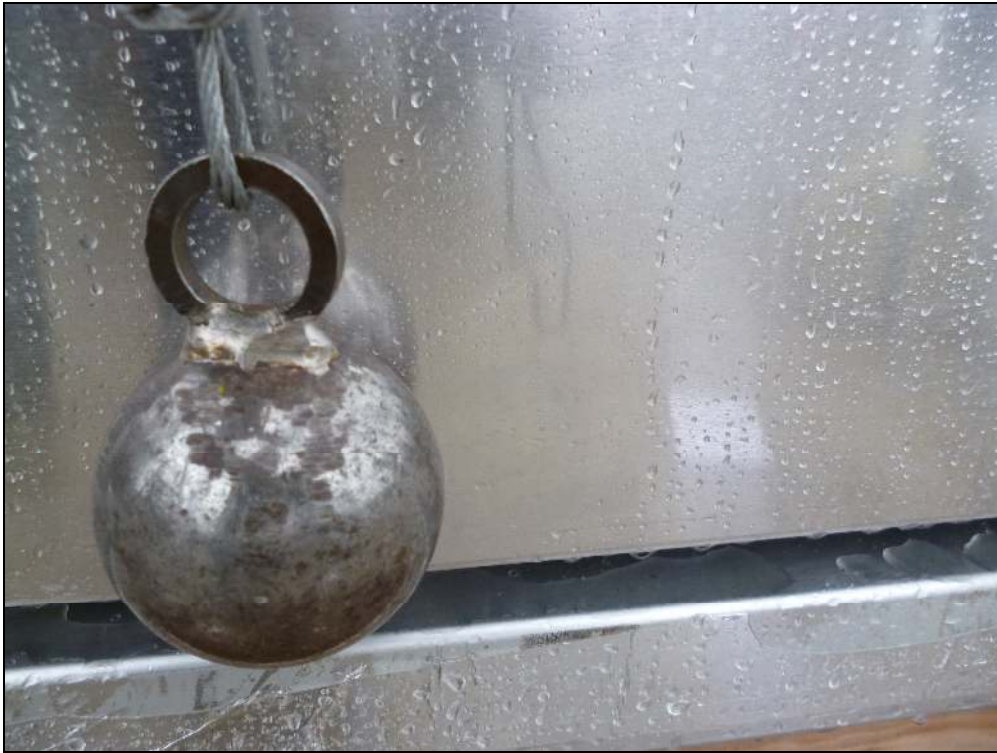
The hard body impactor was a solid steel ball of 62.5 mm diameter and approximate mass of 1.0 kg.

HARD BODY IMPACTOR

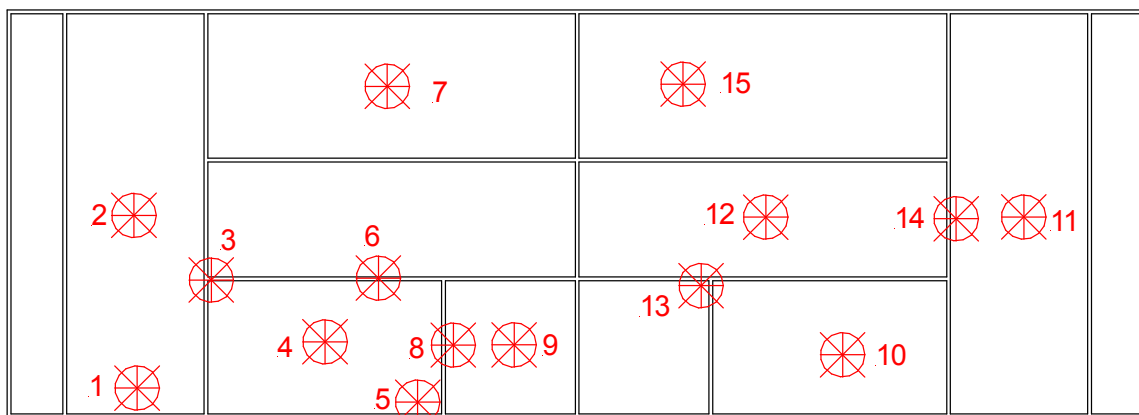
FIGURE 5

SOFT BODY IMPACT TEST LOCATIONS

External View

soft body impact

The impactor almost touched the face of the sample when at rest. It was swung in a pendular movement to hit the sample normal to its face. The test was performed at the locations shown in Figure 5. The impact energies were 120 Nm, carried out three times and 500 Nm carried out once at each location.

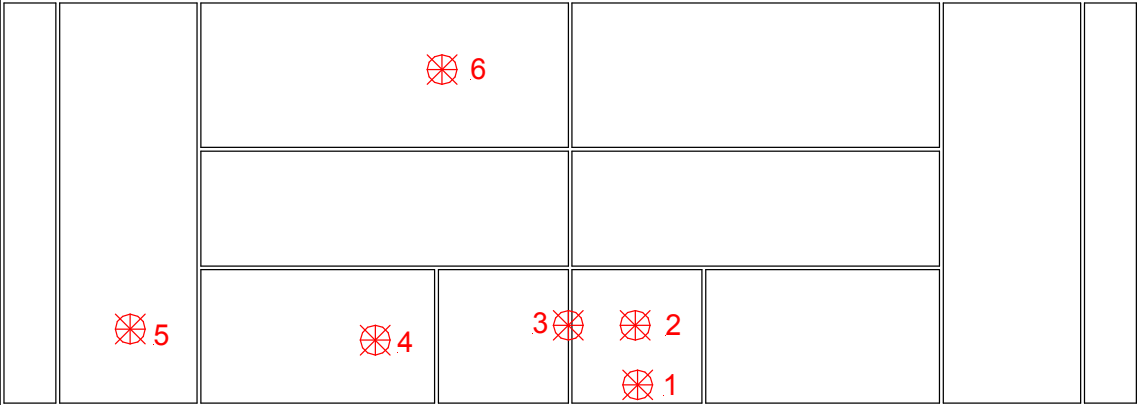
FIGURE 6

HARD BODY IMPACT TEST LOCATIONS

External View

hard body impact

The impactor almost touched the face of the sample when at rest. It was swung in a pendular movement to hit the sample normal to its face. The test was performed at the locations shown in Figure 6. The impact energy was 10 Nm.

Minor indentation was observed at locations 1 and 2 after hard body impacts at 10 Nm. These indents were less than 1 mm deep.

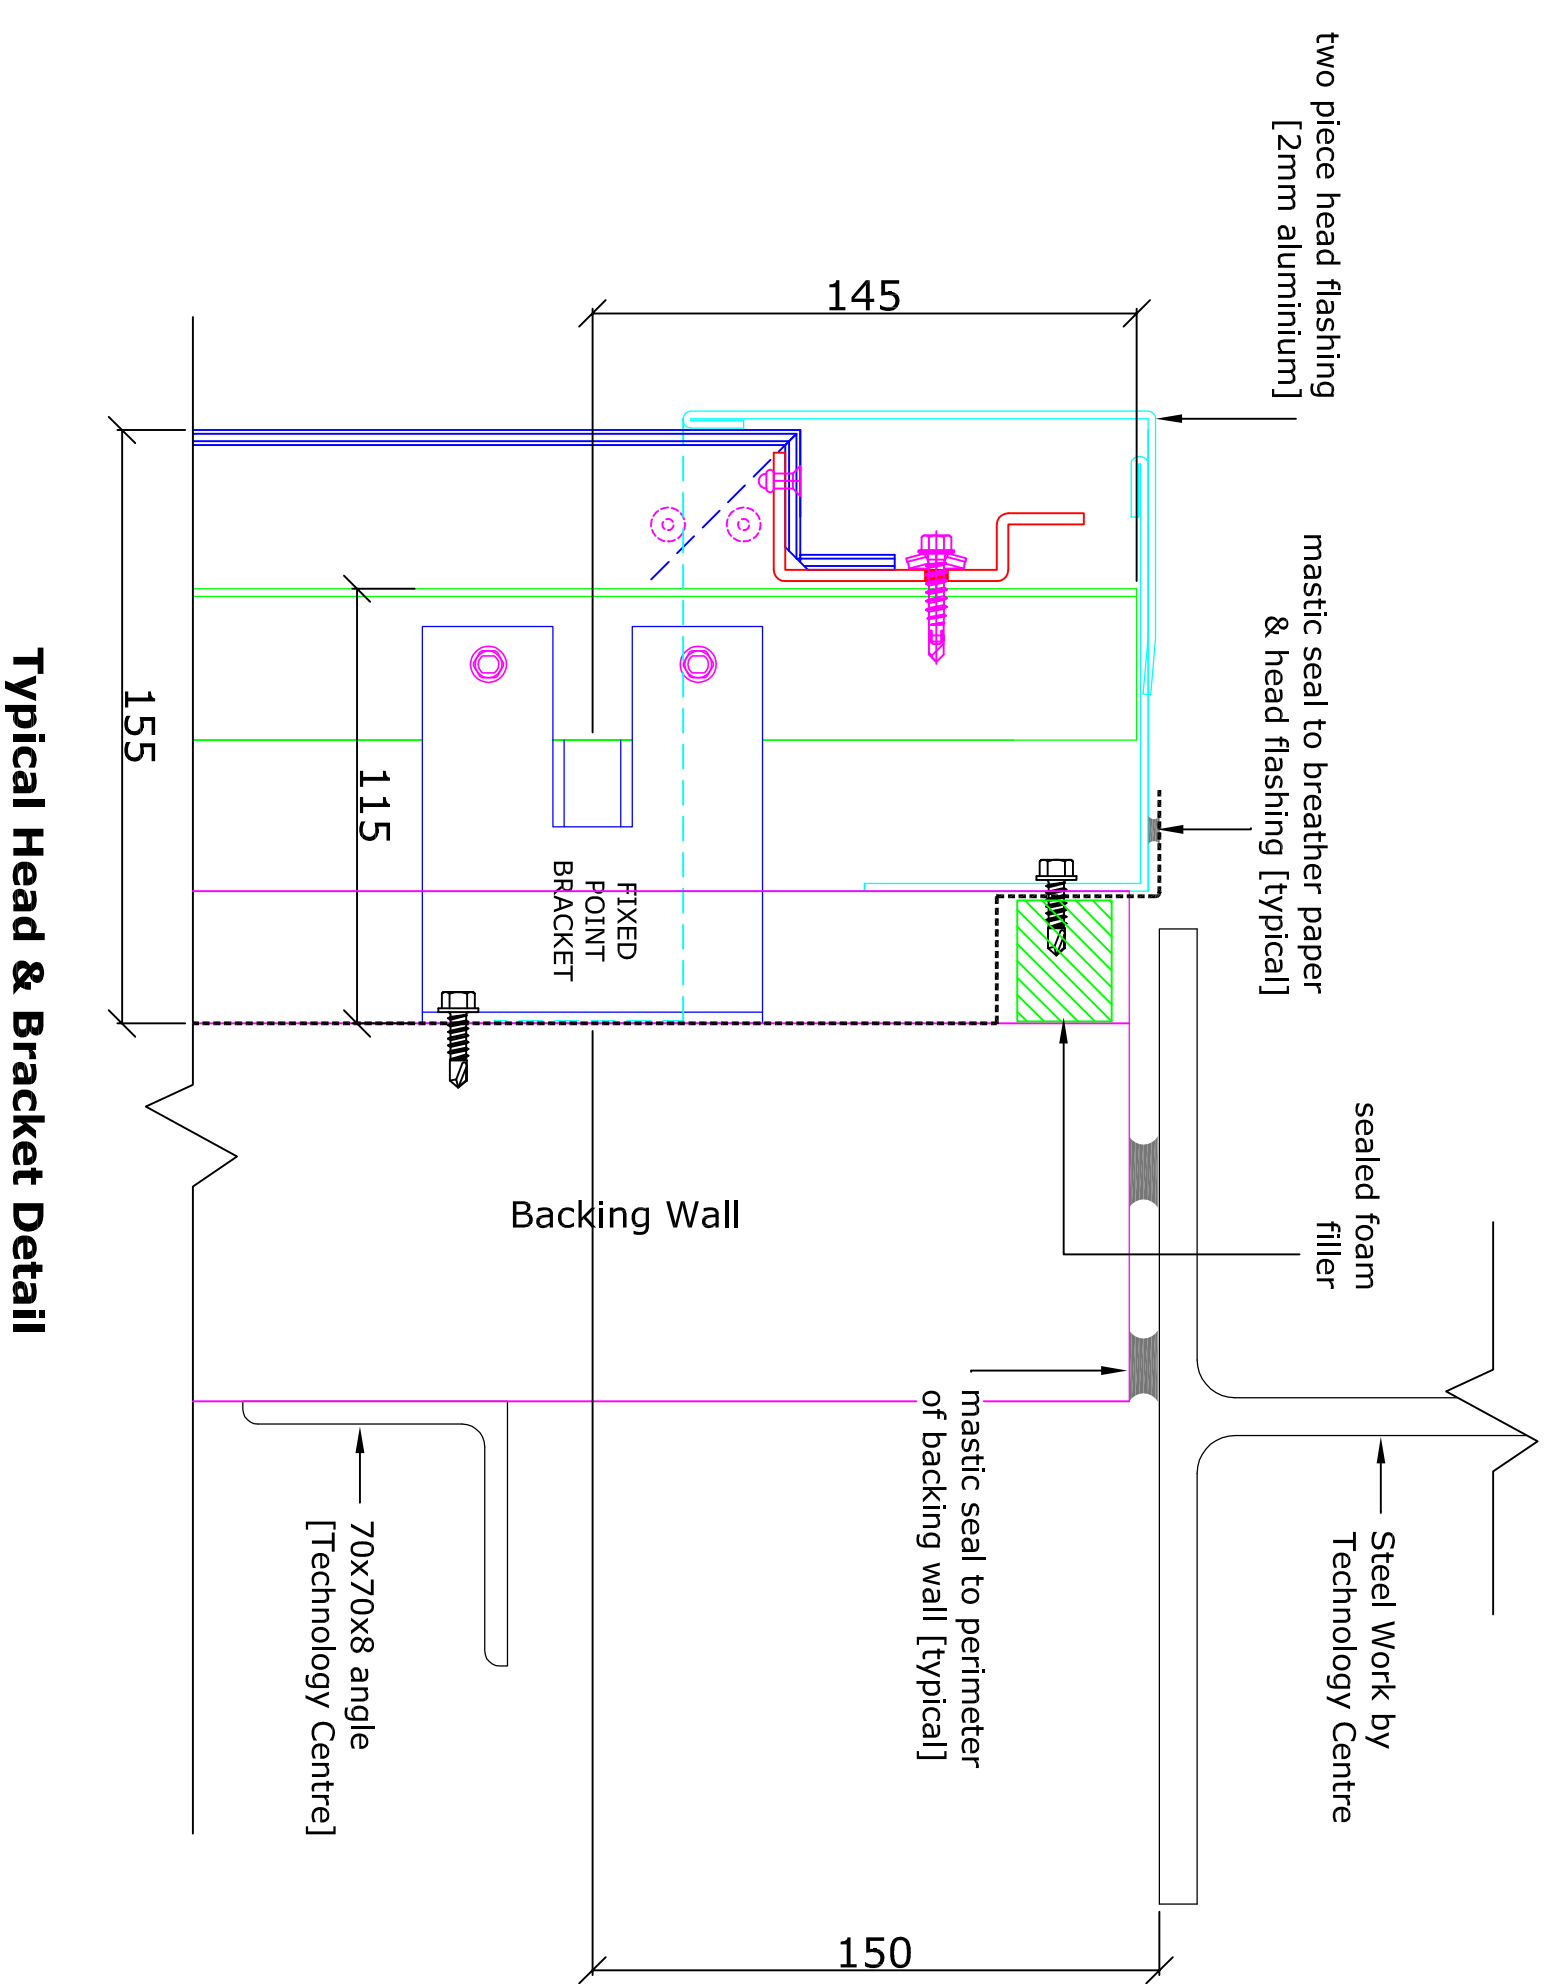
Typical Head & Bracket Detail

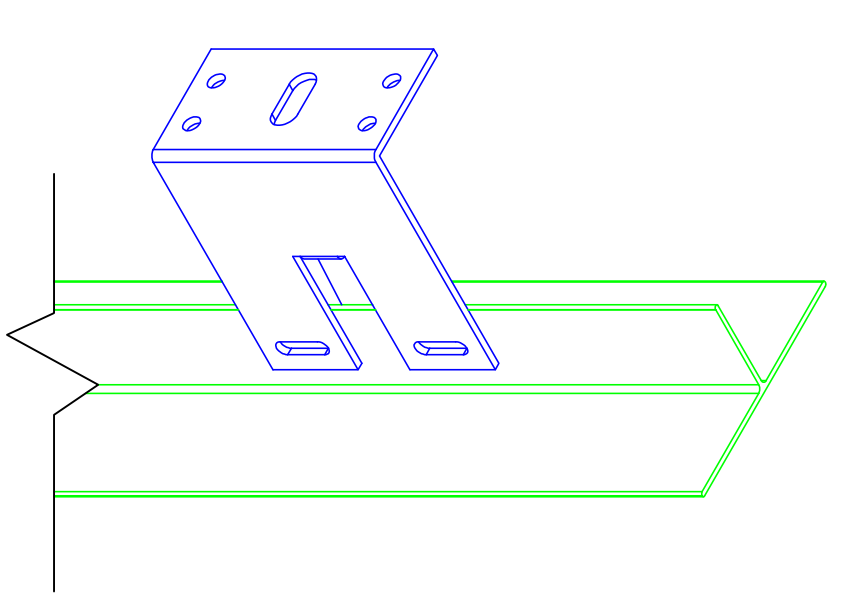
Typical Bracket & T Carrier Detail
