Title: Product weathertightness testing of a Matrix "IP" Rainscreen Cladding system for PSP Architectural Limited

Report No: N950-12-16511

**Client:** PSP Architectural Ltd  
Unit 11, All Saints Industrial Estate,  
Shildon, County Durham DL4 2RD

**Issue date:** 23 February 2012

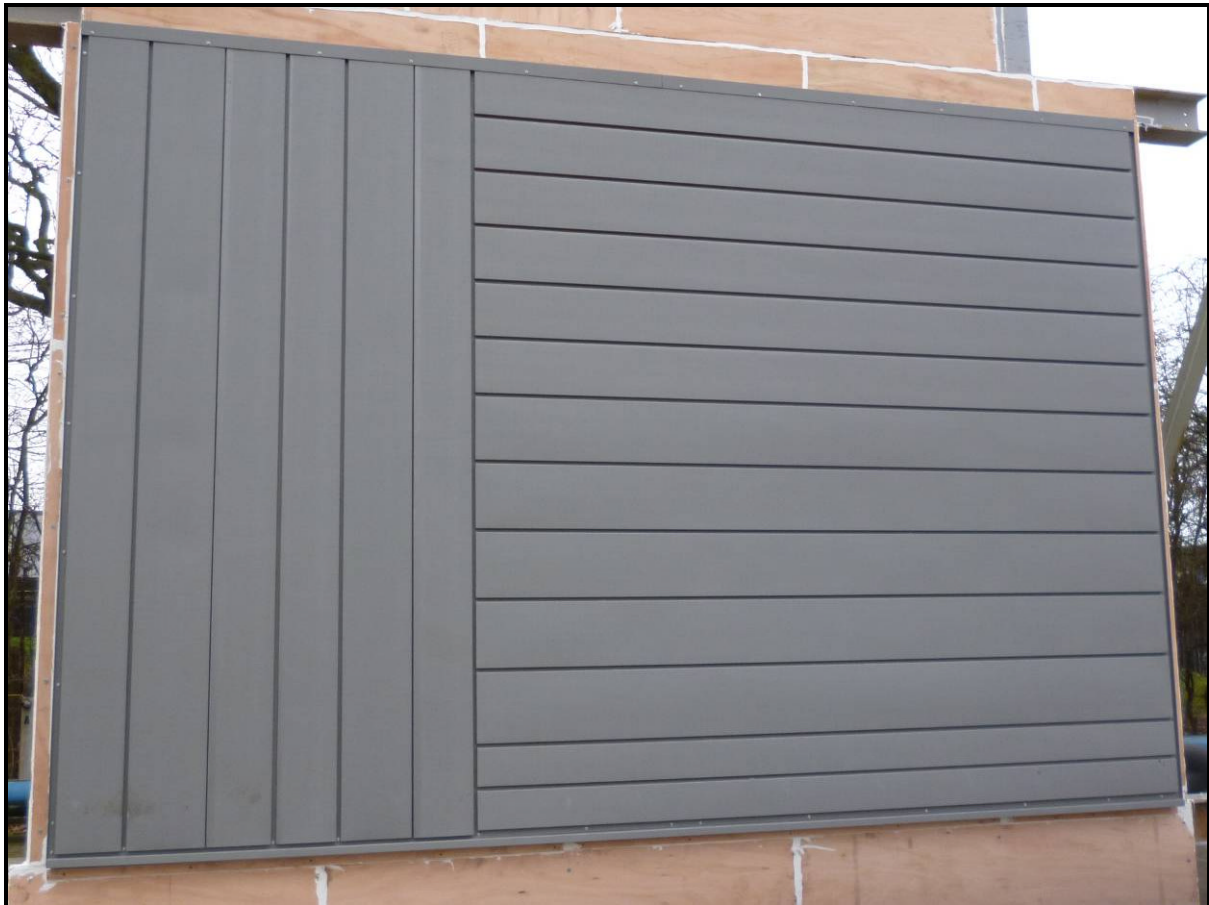
PHOTO 1010111

The rainscreen used 1 mm thick zinc panels.

TEST SAMPLE ELEVATION

The sample was as shown in the photo below and the drawings included as an appendix to this report.

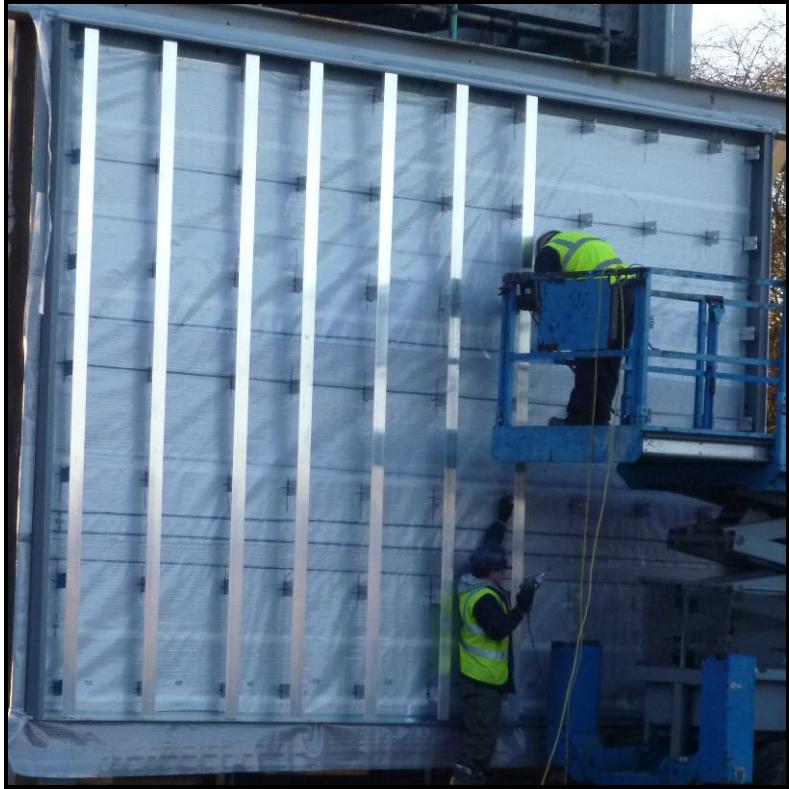
PHOTO 1010101

TEST SAMPLE DURING CONSTRUCTION

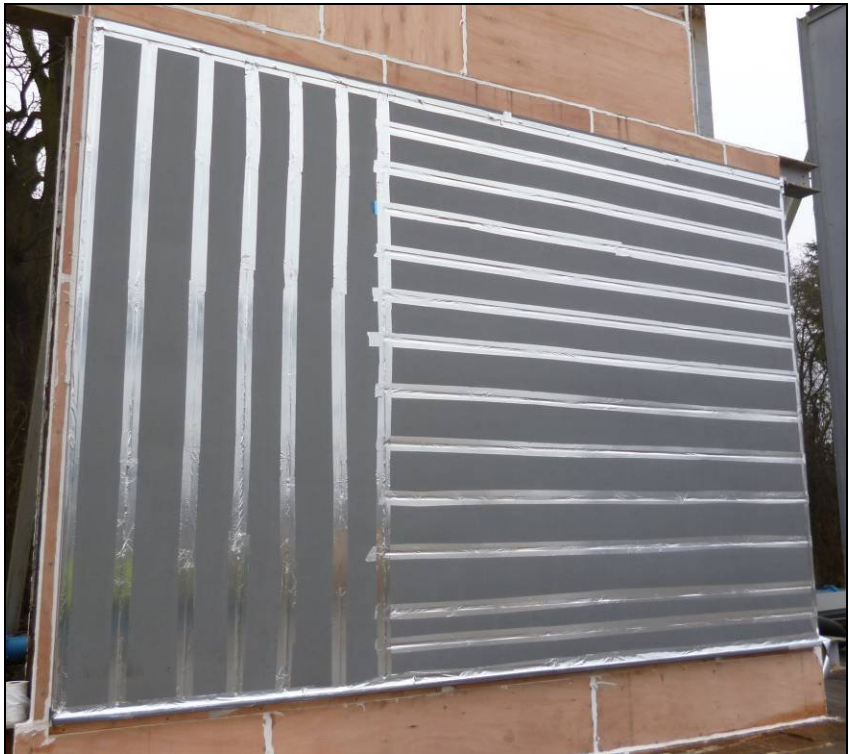
PHOTO 1010113

TEST SAMPLE SEALED FOR WIND REISTANCE TESTING

**Note:** The above tests were carried out on the backing wall. The tests were then repeated on the rainscreen panels. To do this, holes were made through the backing wall, and the joints between the rainscreen panels were sealed over with aluminium tape.

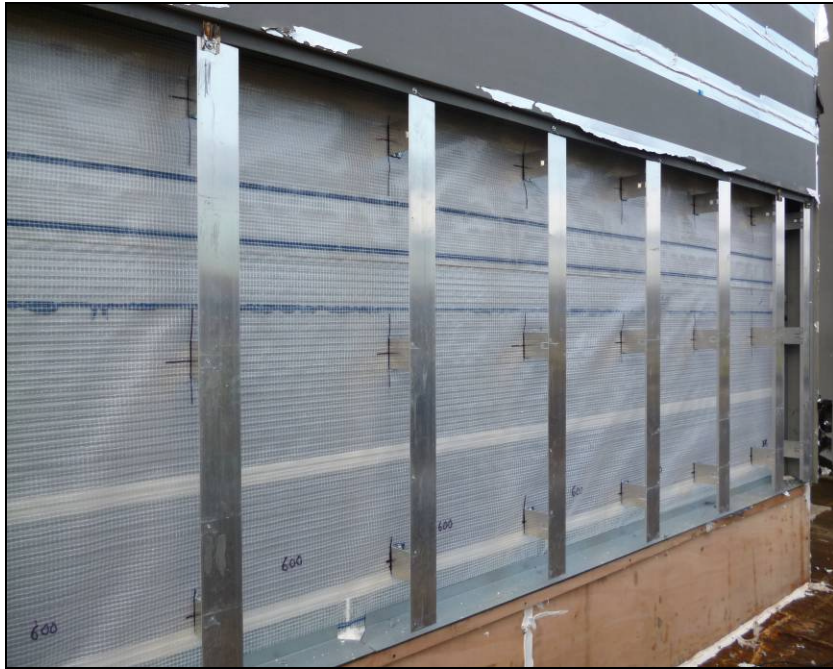
PHOTO 1010173

During the dismantling of the sample no water penetration or discrepancies from the drawing were found.

SUPPORT RAILS AT BASE OF SAMPLE

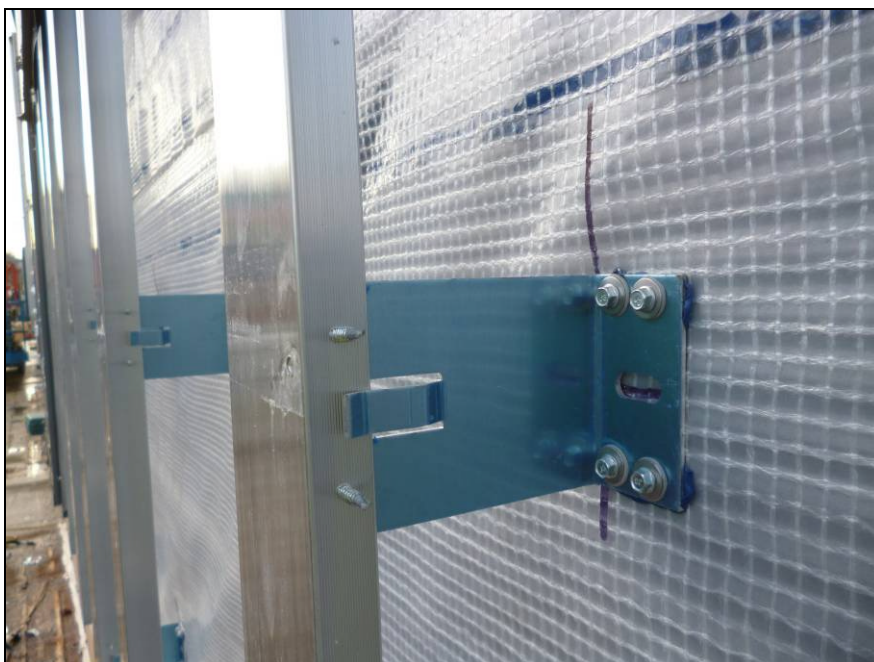
PHOTO 1010174

RAIL SUPPORT BRACKETS

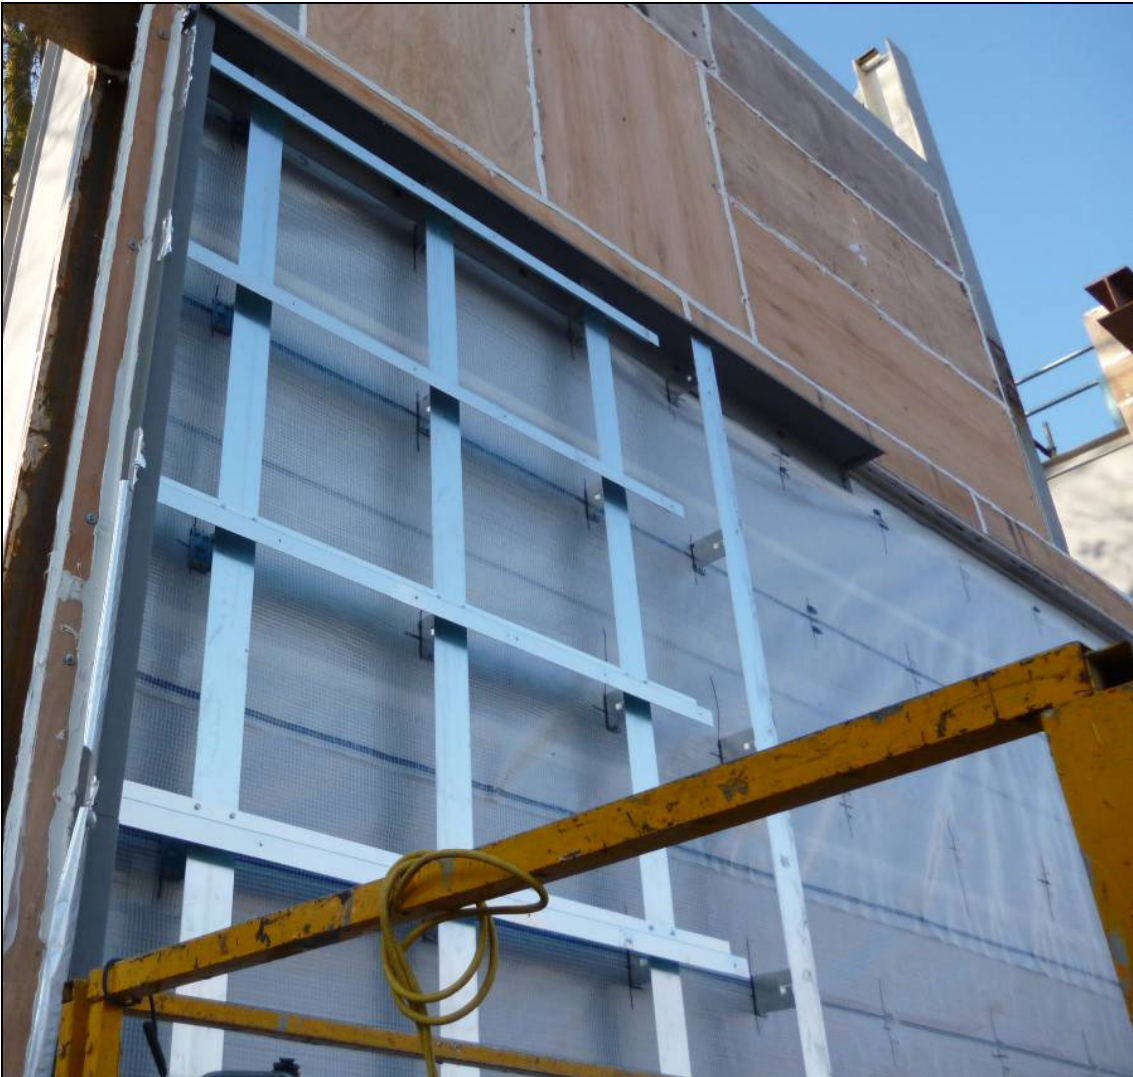
LEFT HAND SUPPORT FRAME

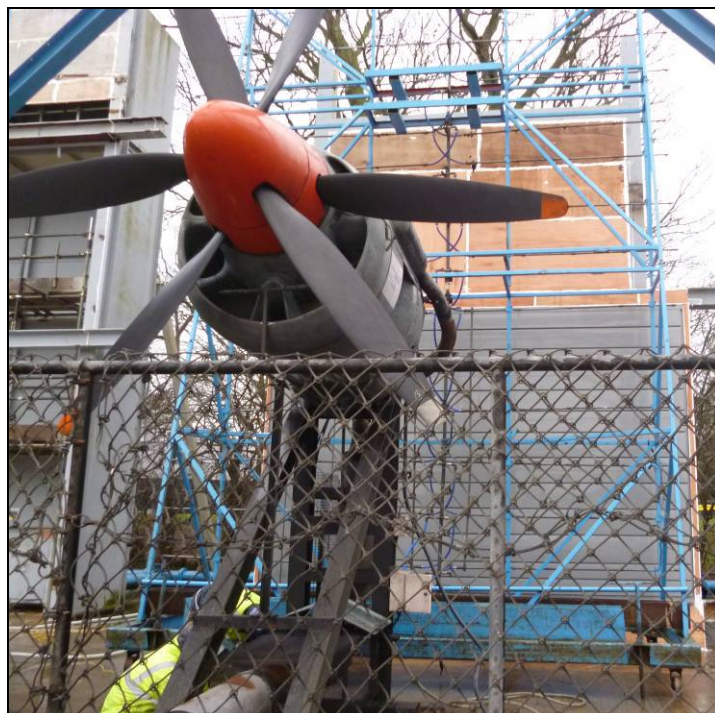
PHOTO 1010112

A wind generator was mounted adjacent to the external face of the sample and used to create positive pressure differentials during dynamic testing. The wind generator comprised a piston type aero-engine fitted with 4 m diameter contra-rotating propellers.

WIND GENERATOR IN FRONT OF SAMPLE

The aero-engine was used to subject the sample to wind of sufficient velocity to produce average deflections in the principle framing members equal to those produced by a static pressure differential of 600 pascals. Suction was applied to the inside of the specimen to achieve the required test deflections but was limited to 25% of the peak static pressure. These conditions were maintained for 15 minutes. Throughout the test the inside of the sample was examined for water penetration.

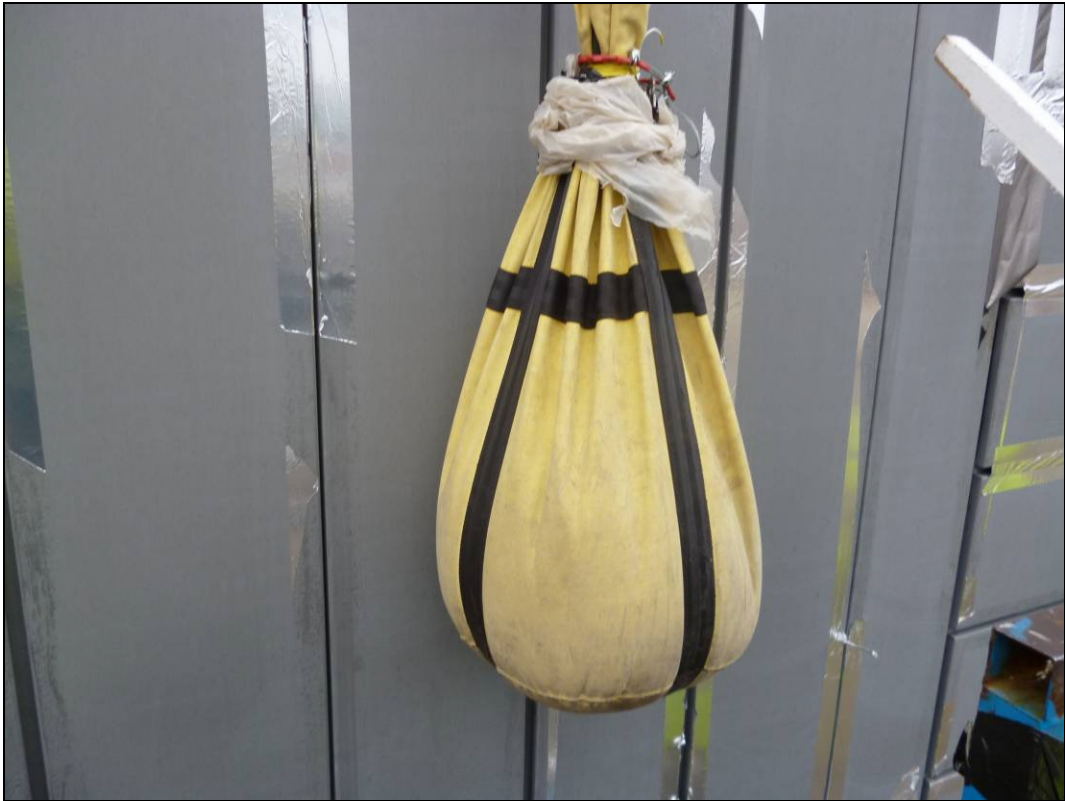
PHOTO 1010115

The soft body impactor comprised a canvas spherical/conical bag 400 mm in diameter filled with 3 mm diameter glass spheres with a total mass of approximately 50 kg suspended from a cord at least 3 m long.

**SOFT BODY IMPACTOR**

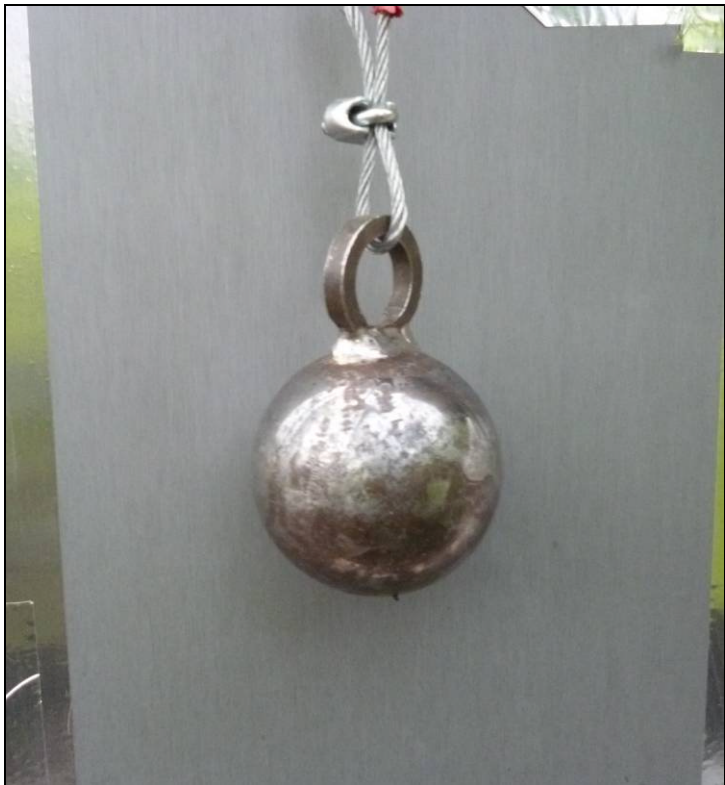
PHOTO 1010127

The hard body impactor was a solid steel ball of 62.5 mm diameter and approximate mass of 1.0 kg.

**HARD BODY IMPACTOR**

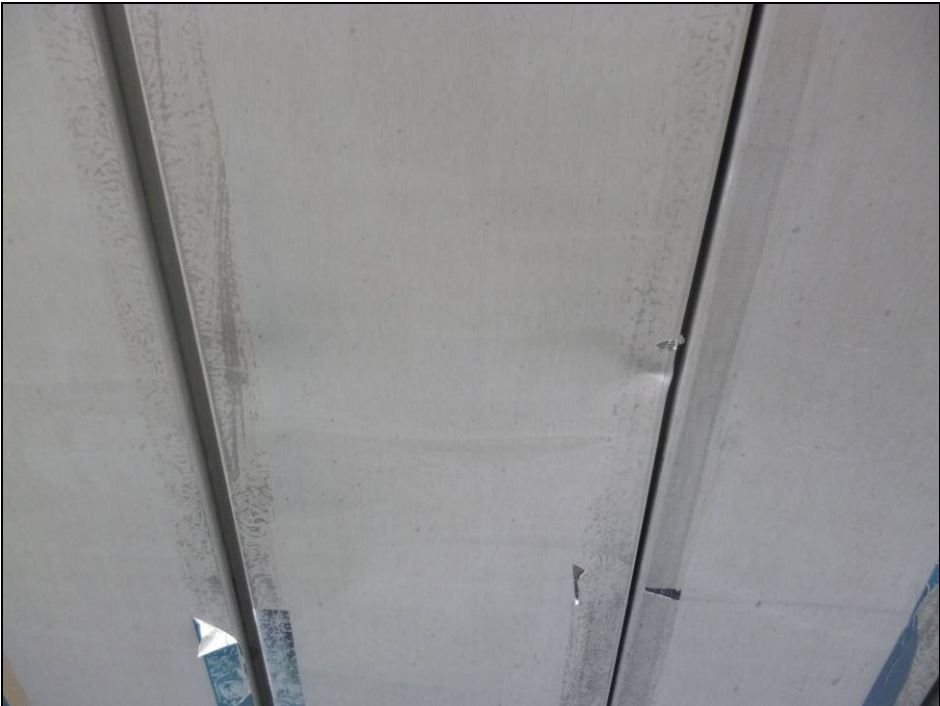
PHOTO 1010114

LOCATION 1 AFTER 500 NM IMPACT

Location	Impact energy (Nm)	Observation
1	120 (soft body) 500 (soft body)	1 mm indent in panel – remained secure. 18mm indent in panel – remained secure.
2	120 (soft body) 500 (soft body)	2 mm indent in panel – remained secure. 20 mm indent in panel – remained secure.
3	120 (soft body) 500 (soft body)	2 mm indent in panel – remained secure. 19 mm indent in panel – remained secure.
4	120 (soft body) 500 (soft body)	2 mm indent in panel – remained secure. 24 mm indent in panel – remained secure.
5	120 (soft body) 500 (soft body)	No damage observed. 14 mm indent in panel – remained secure.
6	120 (soft body) 500 (soft body)	1 mm indent in panel – remained secure. 16 mm indent in panel – remained secure.
7	120 (soft body) 500 (soft body)	1 mm indent in panel – remained secure. 15 mm indent in panel – remained secure.
8	120 (soft body) 500 (soft body)	No damage observed. 12 mm indent in panel – remained secure.

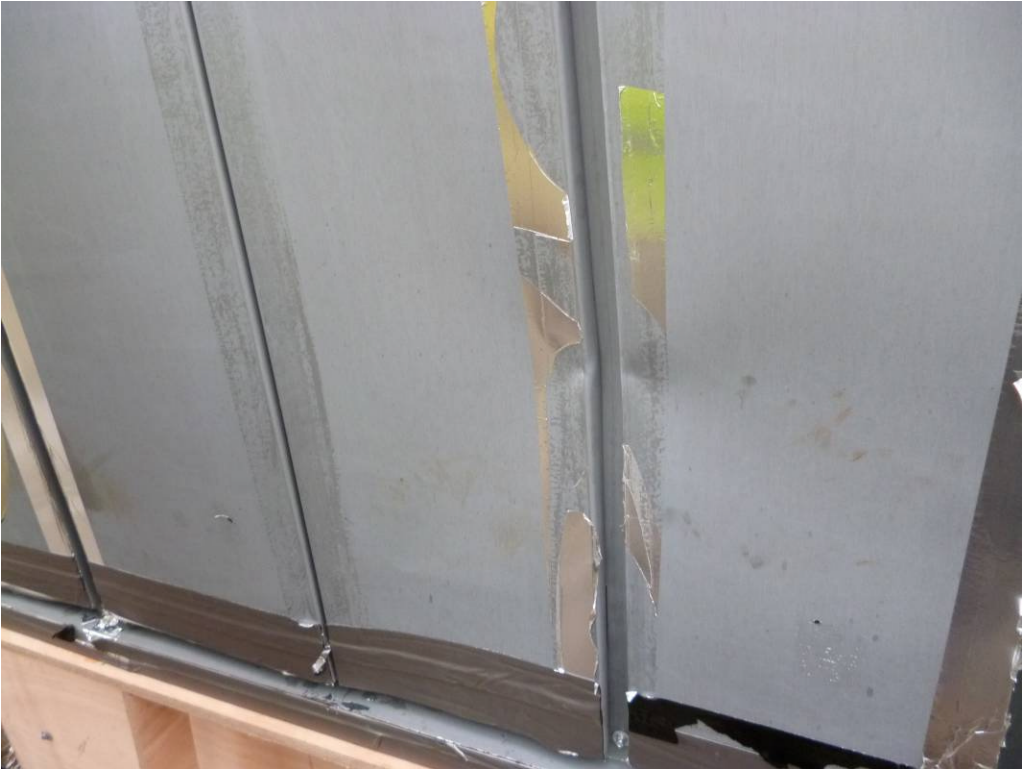
PHOTO 1010120

LOCATION 4 AFTER 500 NM IMPACT

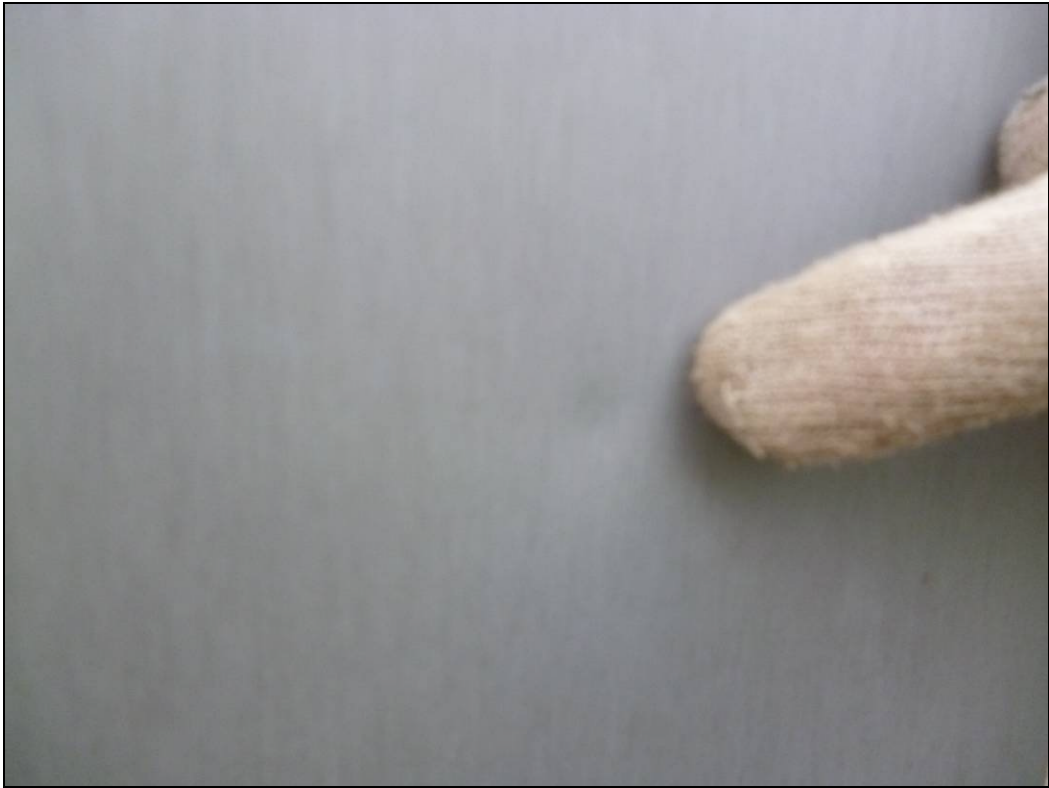
PHOTO 1010128

LOCATION 13 AFTER 10 NM IMPACT

9	120 (soft body) 500 (soft body)	No damage observed. 14 mm indent in panel – remained secure.
10	120 (soft body) 500 (soft body)	No damage observed. 10 mm indent in panel – remained secure.
11	120 (soft body) 500 (soft body)	No damage observed. 8 mm indent in panel – remained secure.
12	120 (soft body) 500 (soft body)	No damage observed. 9 mm indent in panel – remained secure.
13	10 (hard body)	Minor indent less than 1 mm deep.
14	10 (hard body)	Minor indent less than 1 mm deep.
15	10 (hard body)	Minor indent less than 1 mm deep.
16	10 (hard body)	Minor indent less than 1 mm deep.

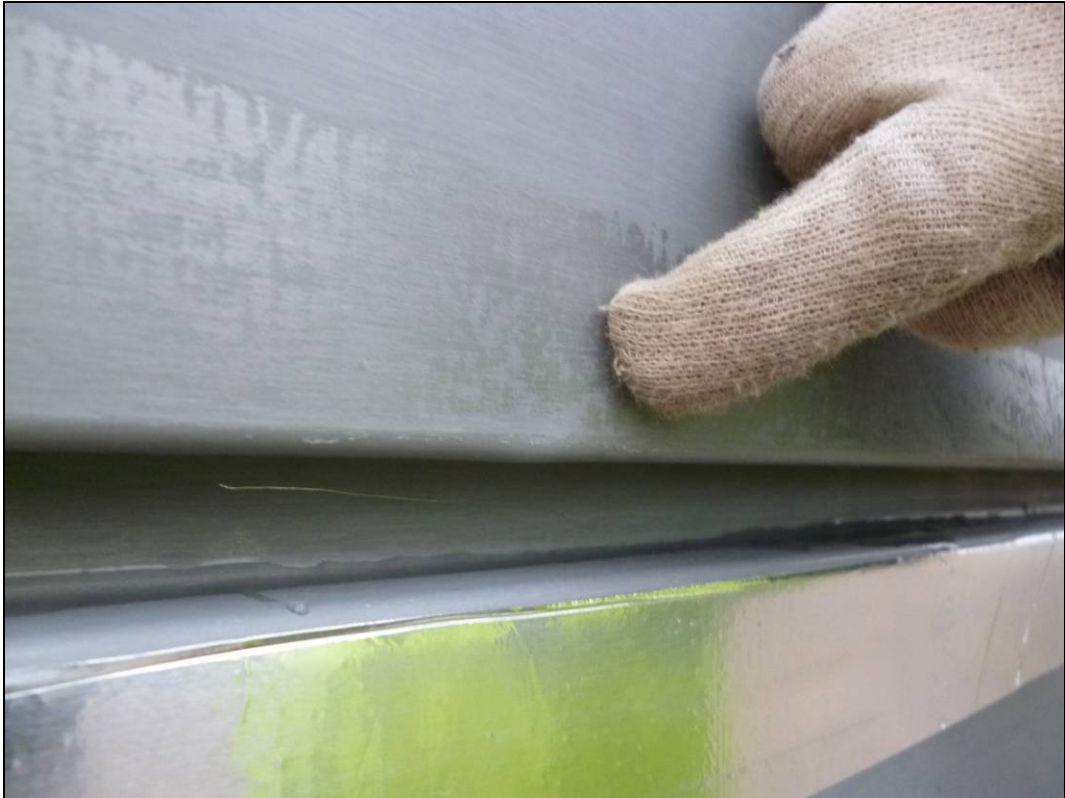
PHOTO 1010132

LOCATION 16 AFTER 10 NM IMPACT

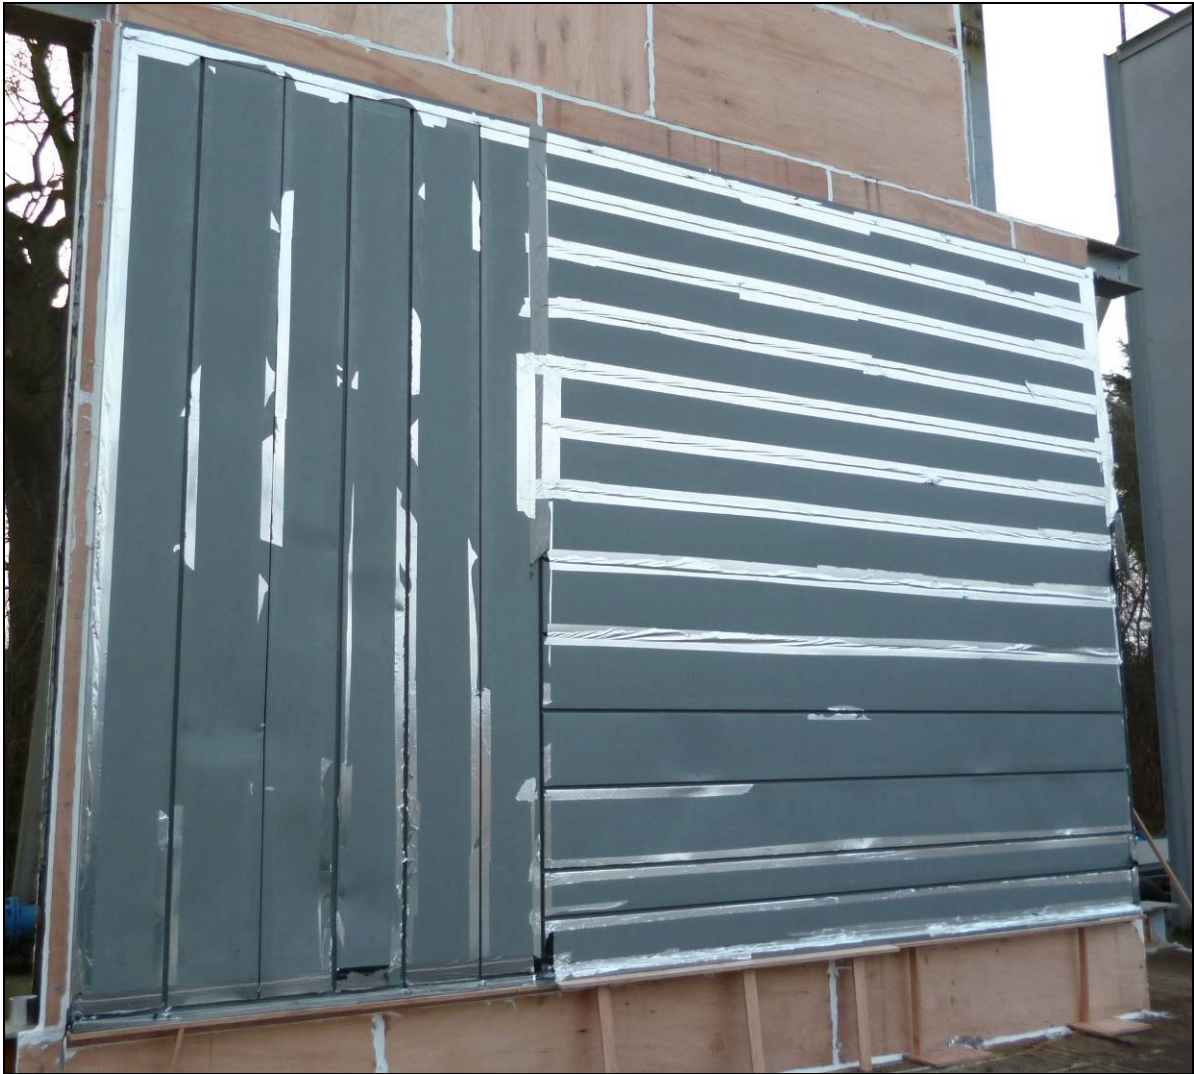
All the panels remained secure after impact testing was complete.

SAMPLE AFTER IMPACT TESTING
